## Occupational Safety and Health Administration

Inspection Number	1. Photo ID No.	2. Date/Time	3. Citation Number	4. Item Number	5. Instance No.
1148200	8835, 8848	5/18/2016	1	1	1

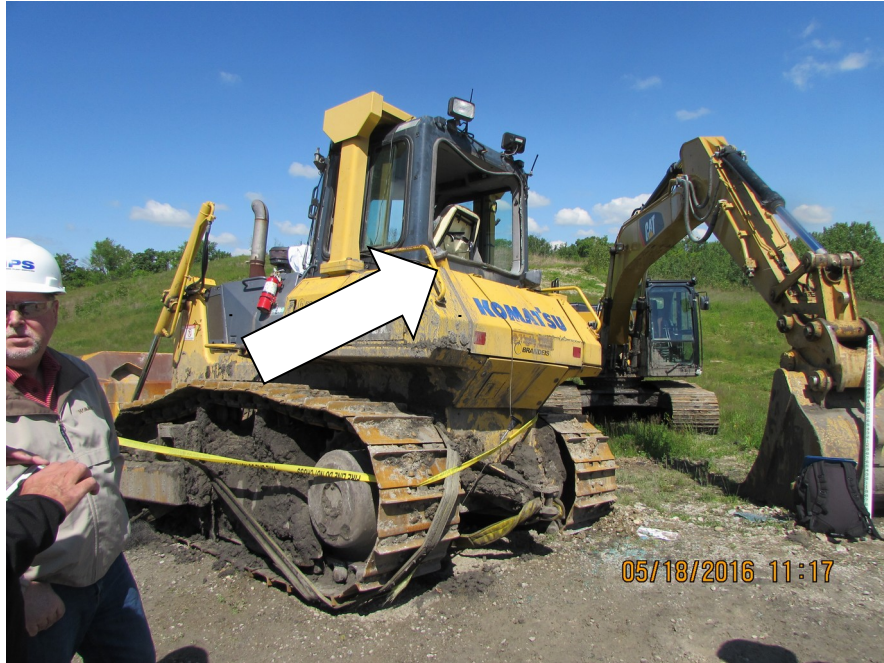
Note: Arrow is pointing to the rear window of the dozer where the impact of the strap/shackle struck the seat and the dozer operator.

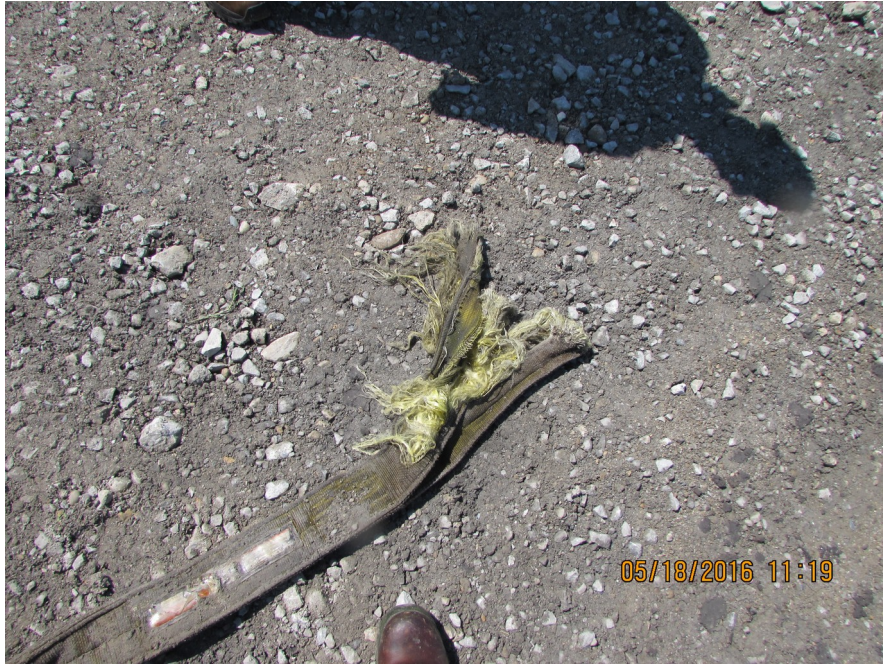
This photo is the 4' X 20 synthetic strap that broke free from the shackle attached to the bucket of the excavator.
